HENRY SEVER DAM
KNOX COUNTY, MISSOURI
MO 10110

**PHASE I INSPECTION REPORT
NATIONAL DAM SAFETY PROGRAM**

DECEMBER 1978

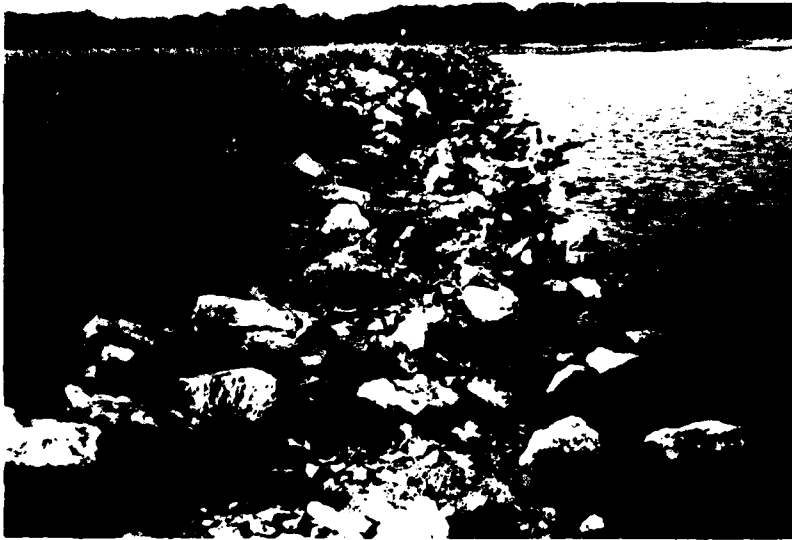
The upstream embankment slope is, for the most part, adequately protected by the riprap described earlier. Some thinning of the riprap and subsequent embankment sloughing is occurring near the left side of the dam, but is not serious at this time, and can be repaired by normal maintenance. No degradation of the riprap blocks due to weathering was observed.

Photo 5 - Close-up of upstream embankment slope taken near left abutment. Note thin riprap and minor sloughing of embankment material.

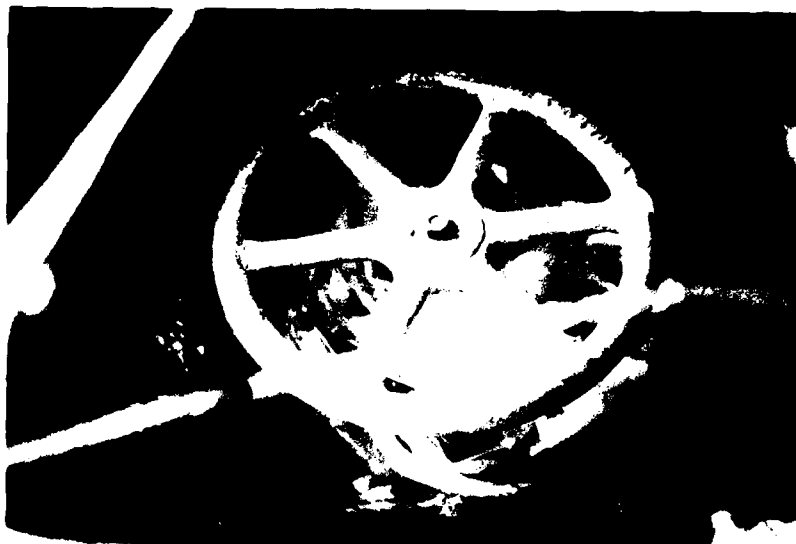
The low level outlet valve is the only operating facility at the damsite. This gate is operated very infrequently. The gate appeared to be maintained well, and in satisfactory operating condition.

Photo 7 - Picture of gate and handwheel in pit shown in previous picture.
